Yarra Ranges Shire Council
Warburton Mountain Bike Destination Project
Geotechnical Risk Assessment

December 2019

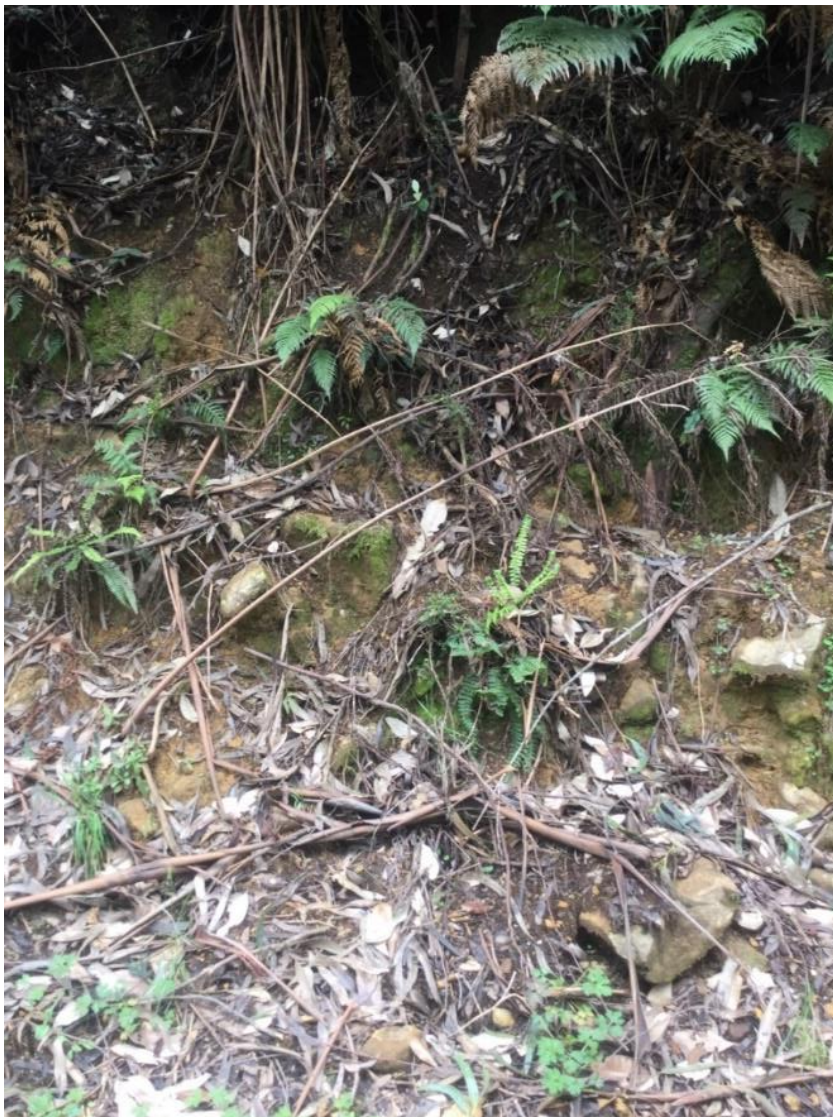
Photo 1 Typical weathered rhyodacite soil (2m high face)

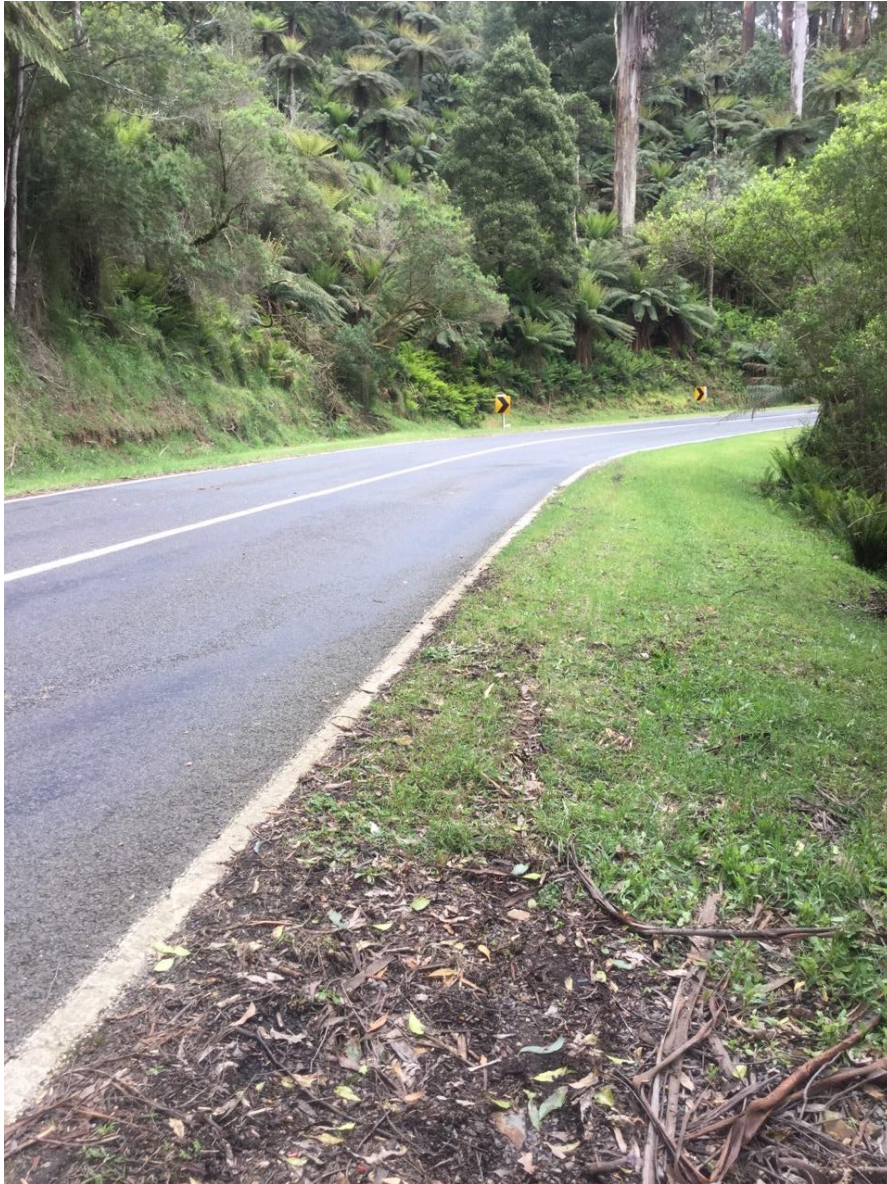
The common failure type recorded within the Donna Buang Rhyodacite is debris flows. This was confirmed during the site inspection. Evidence of debris flows were generally observed at the location of channel/gully systems in the form of debris deposits (colluvium) and cleared/fallen vegetation, described in photos 2, 3 and 4 below.

Photo 2 Colluvial deposit observed either side of channel slopes, underlying and down slope of the road. Tension cracking is observed in the road as well as slumping of the colluvial material downslope. Cleared/fallen trees within gully system that appear to be have been caused by the debris flow.

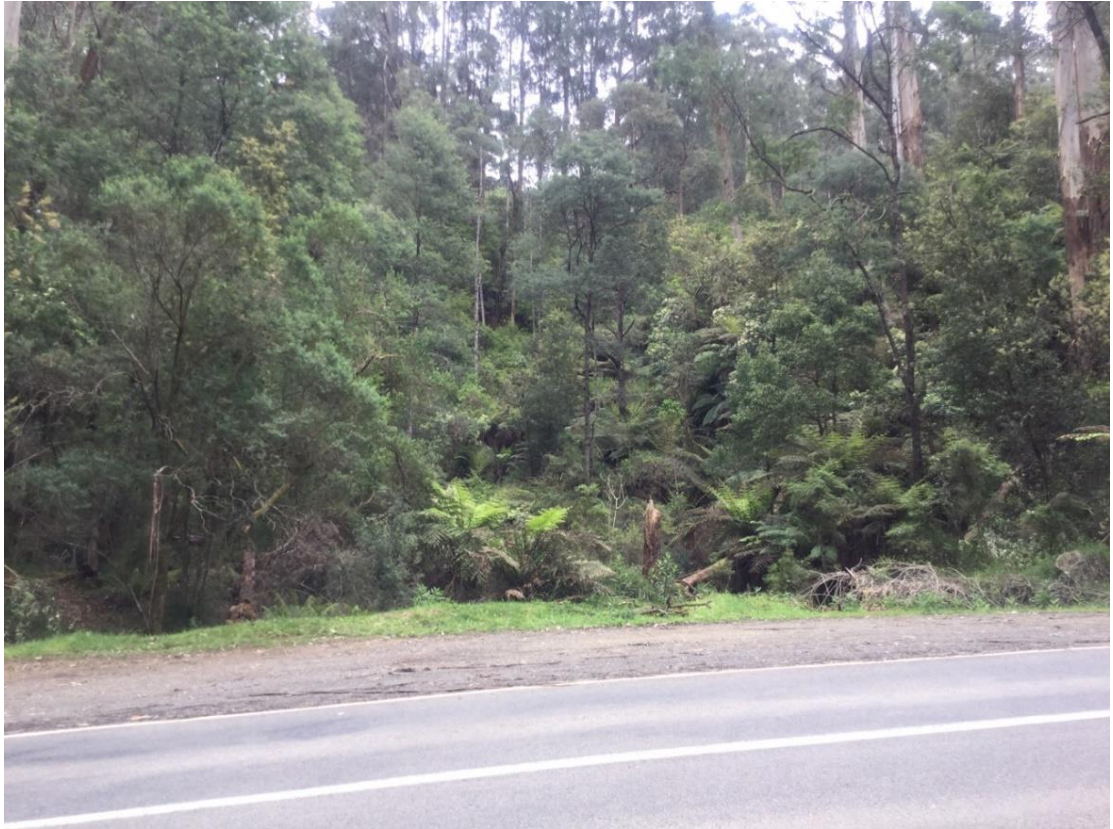
Photo 3 Colluvial deposit at the base of a gully. Road is constructed on colluvium which is also observed at the base of the gully sides. Ponding is also occurring at the surface of the colluvial material

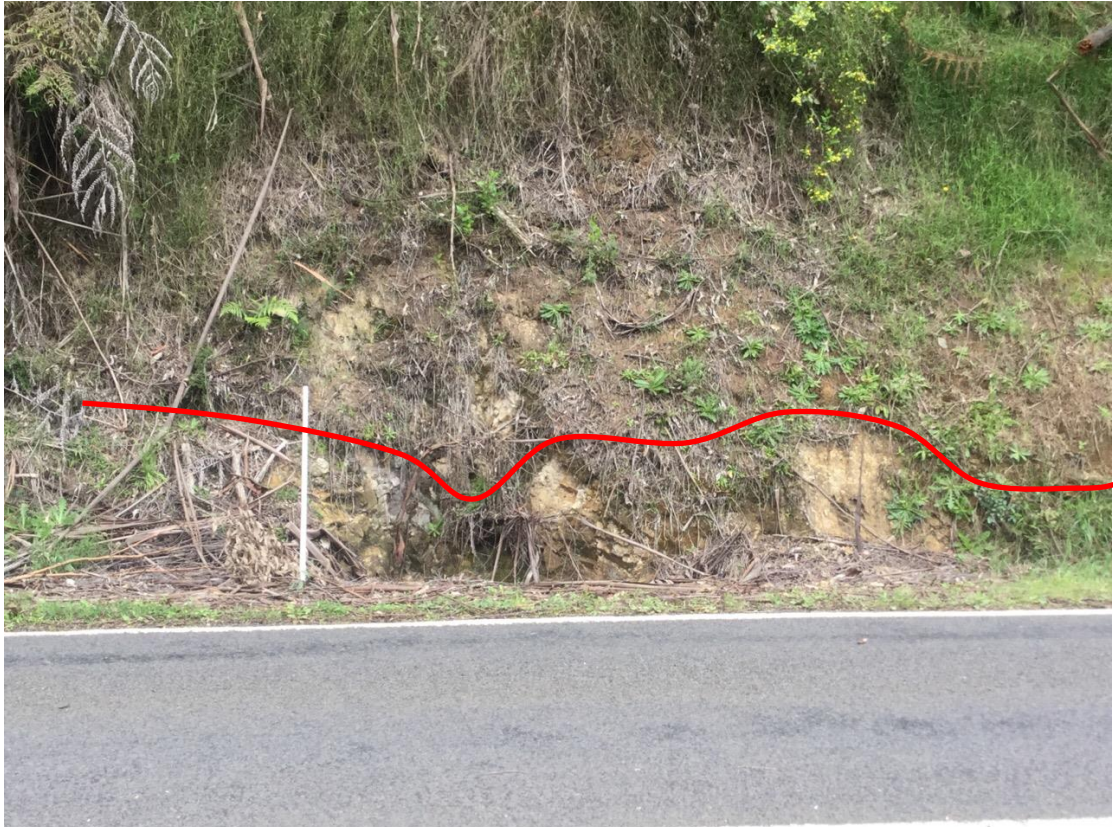
Photo 4 Interface between colluvium and rhyodacite rock. Colluvium consists of loose debris including rounded gravels and cobbles of rhyodacite. Outcrop in road cutting at the side of gully system

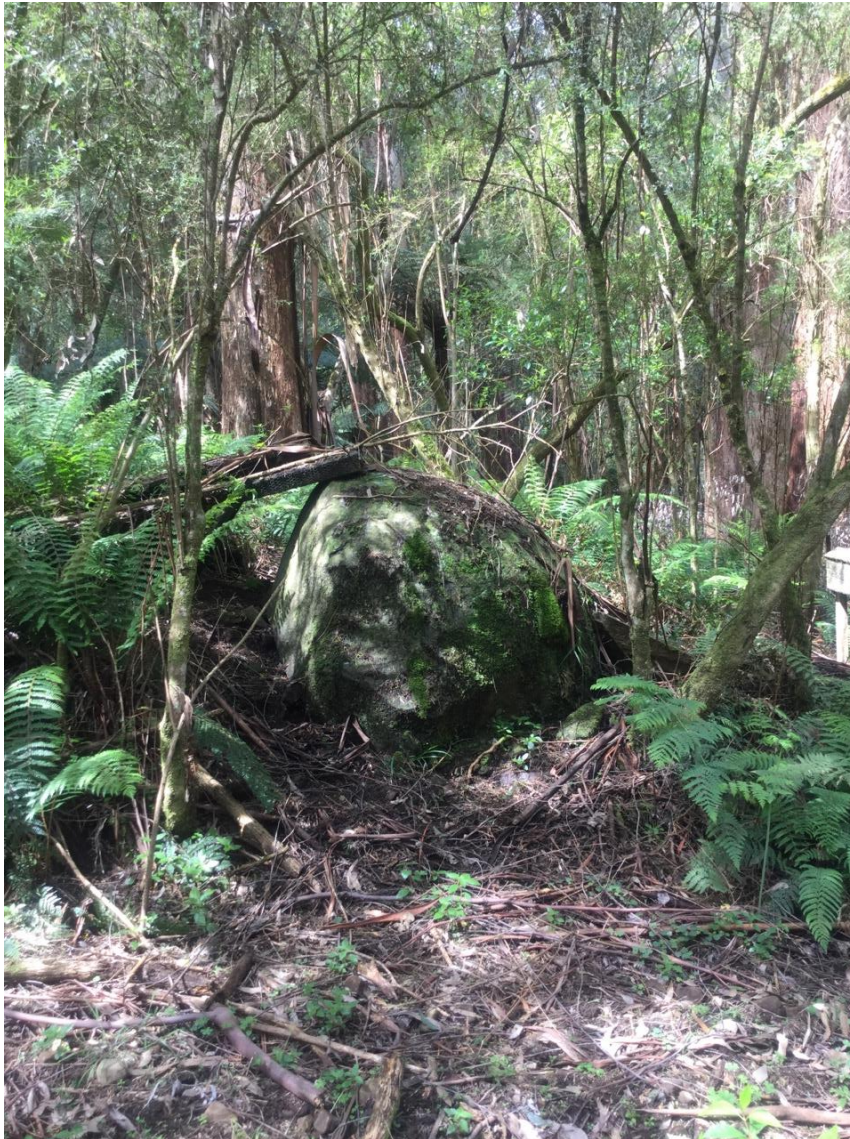
Rock fall is also considered as a potential failure type within the rhyodacite. Boulders present in the weathered soil matrix may be able to come loose following erosion and travel downslope. Photo 6 below is the result of a rockfall.

Photo 5 Rhyodacite boulder (>1m) transported from upslope. Evidence of rock fall event after boulder dislodging from weathered soil matrix following erosion

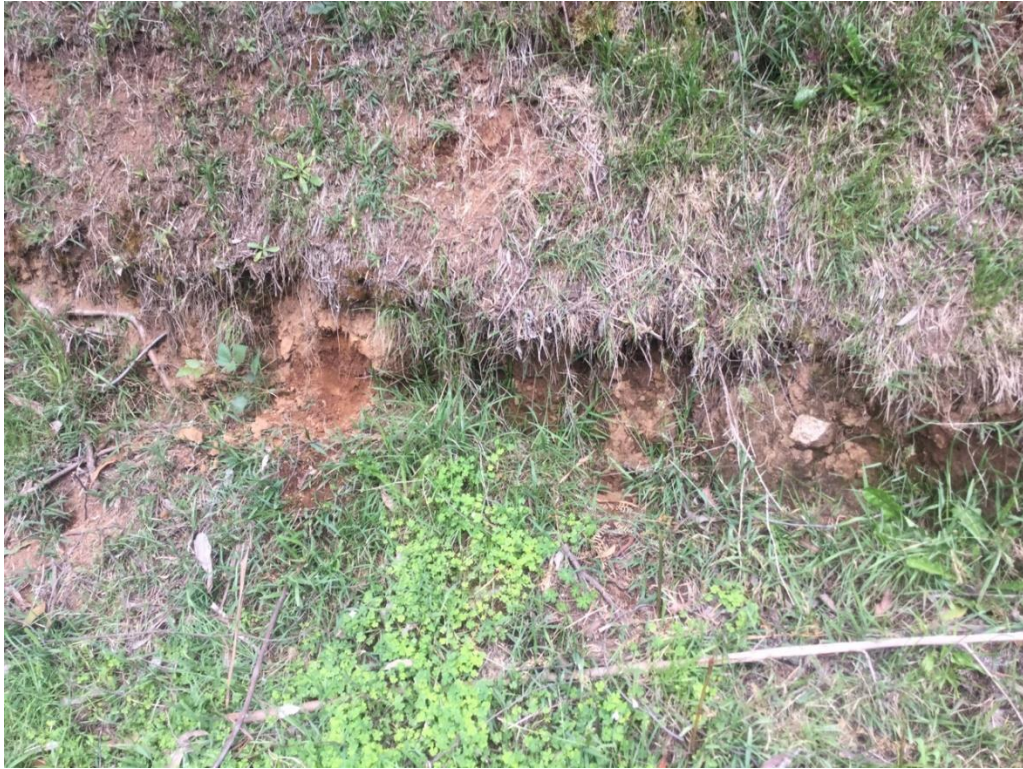
The common failure type in colluvial deposits is the slow moving reactivation of debris material derived from weathered rhyodacite soils observed in the field as creep and historically recorded as translational failures. Small scale failures such as slumping is also observed in the colluvium at road cutting locations caused by over steepening due to its low strength and unstable nature.

Photo 6 Unstable colluvium deposited within a gully which appears to have failed from over steepening of road cutting

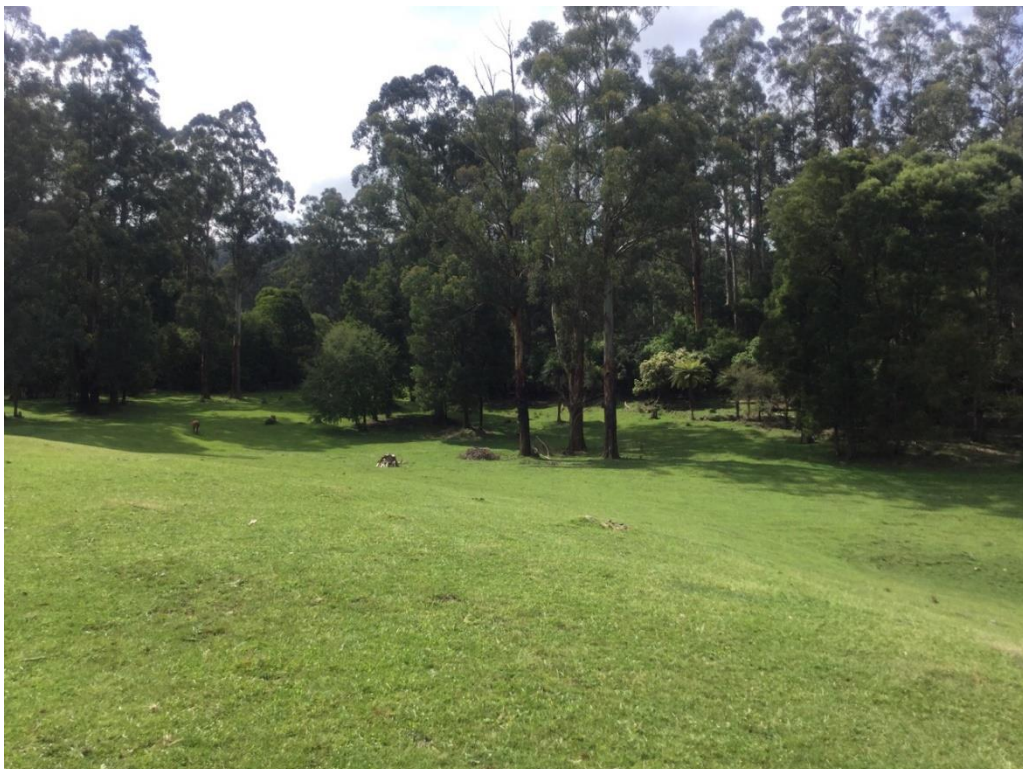
Photo 7 Shallow, undulating slopes at the base of steeper rhyodactie slopes

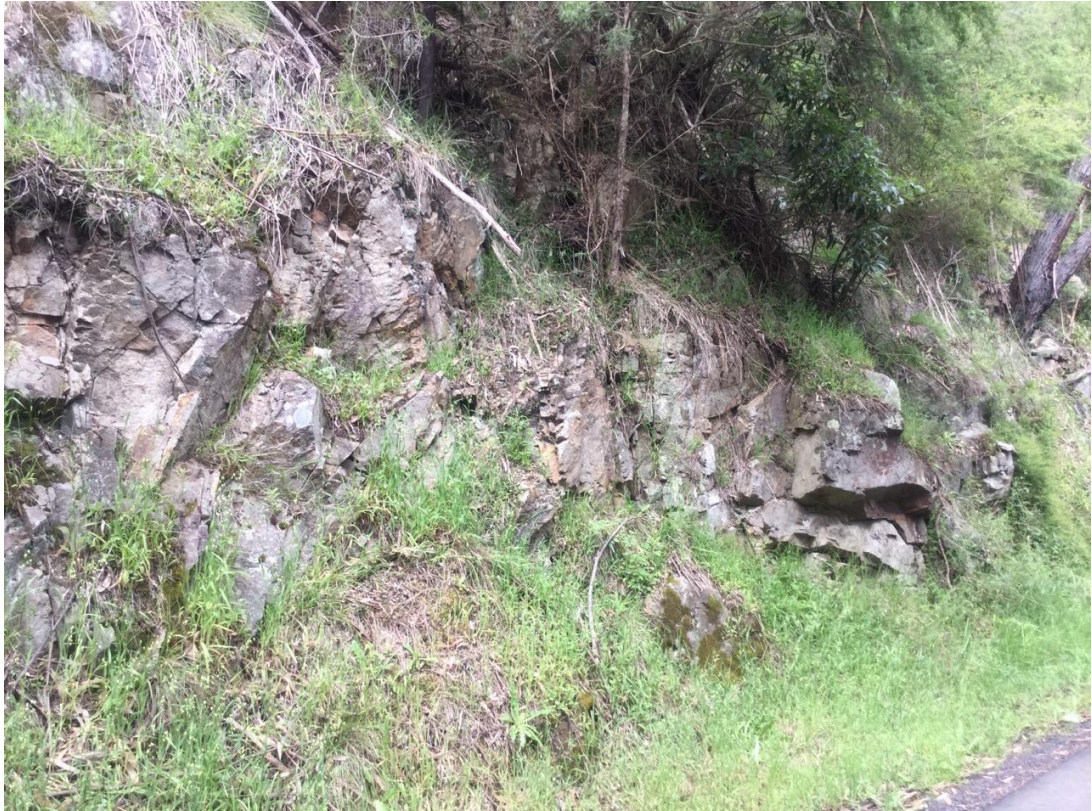
The dyke outcrops generally consist of rock slopes with little soil cover. Photo 8 and 9 below show some of the typical outcrops observed. The quality of rock mass in terms of density and orientation of jointing appears to vary significantly and the intact rock has consistently high strength.

Photo 8 Rock mass observed in dyke cutting along Warburton rail trail

- It is recommended that rock slope protection is installed on the (Felsic Dyke) rock slope cutting exposed along the Warburton rail trail. A simple rock mesh would reduce the risk of rock fall along this section of the rail trail.
- Advise users of the rail trail of rock fall risk following periods of heavy rainfall.

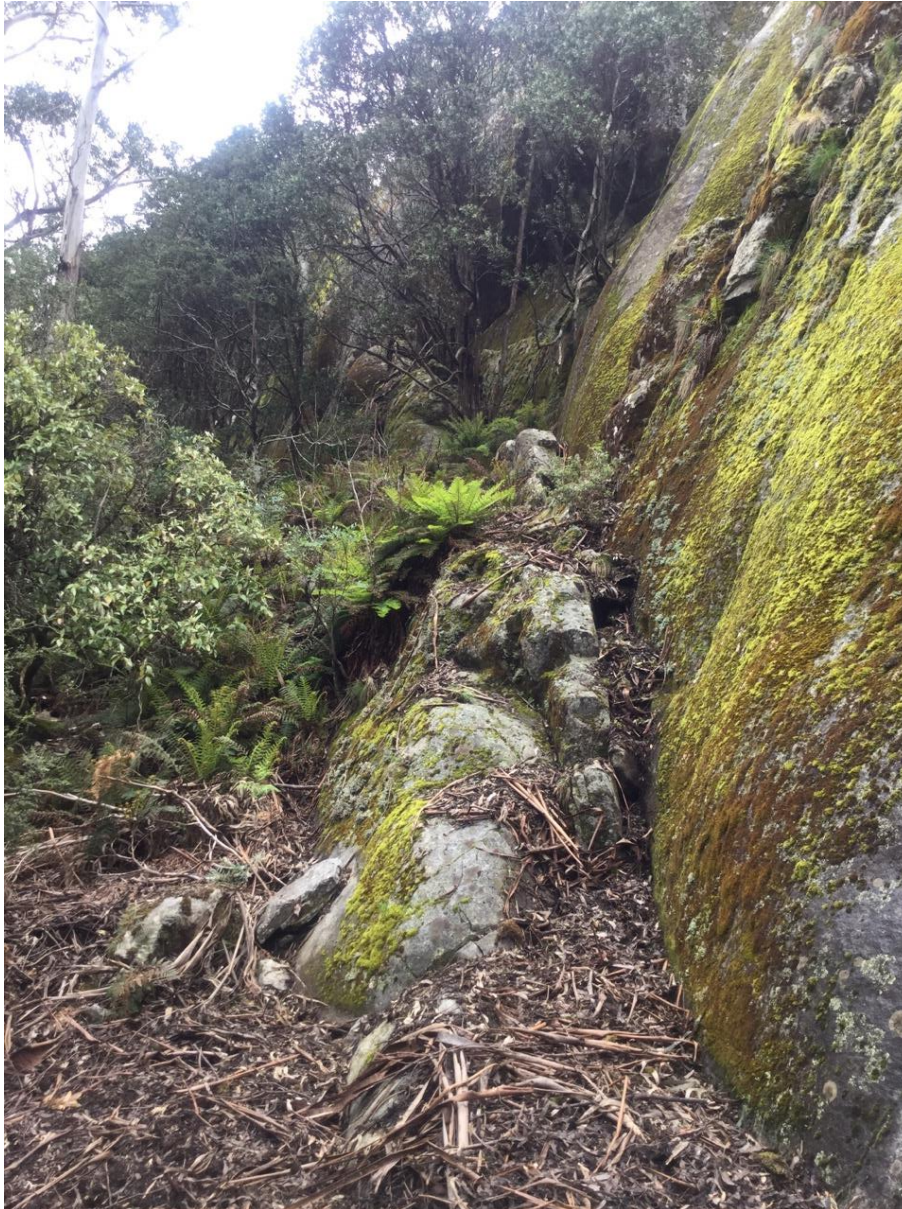
Photo 9 Dyke outcrop making up a rocky ridge on the slopes of Mount Donna Buang. Wider joint spacing and higher quality rock mass

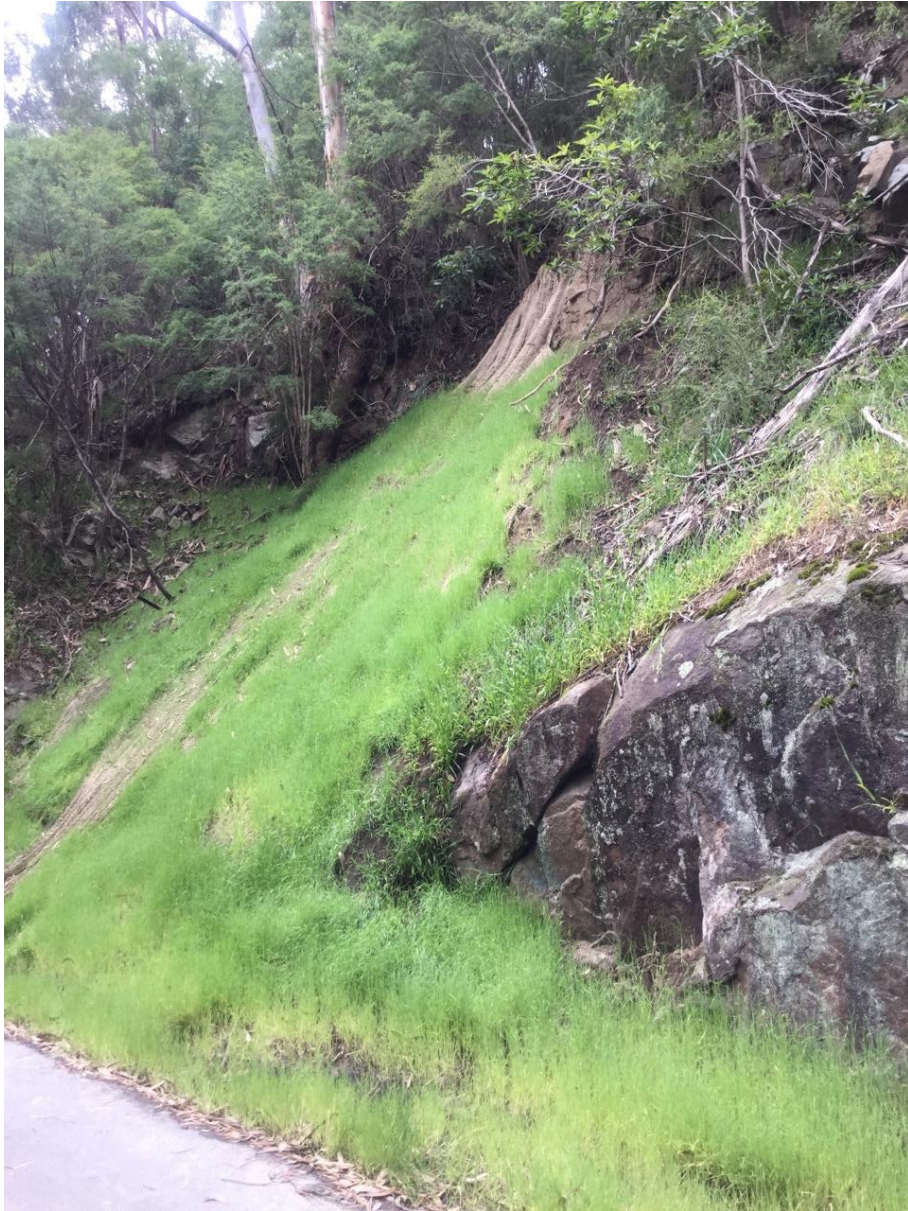
Photo 10 Back scarp of recent failure

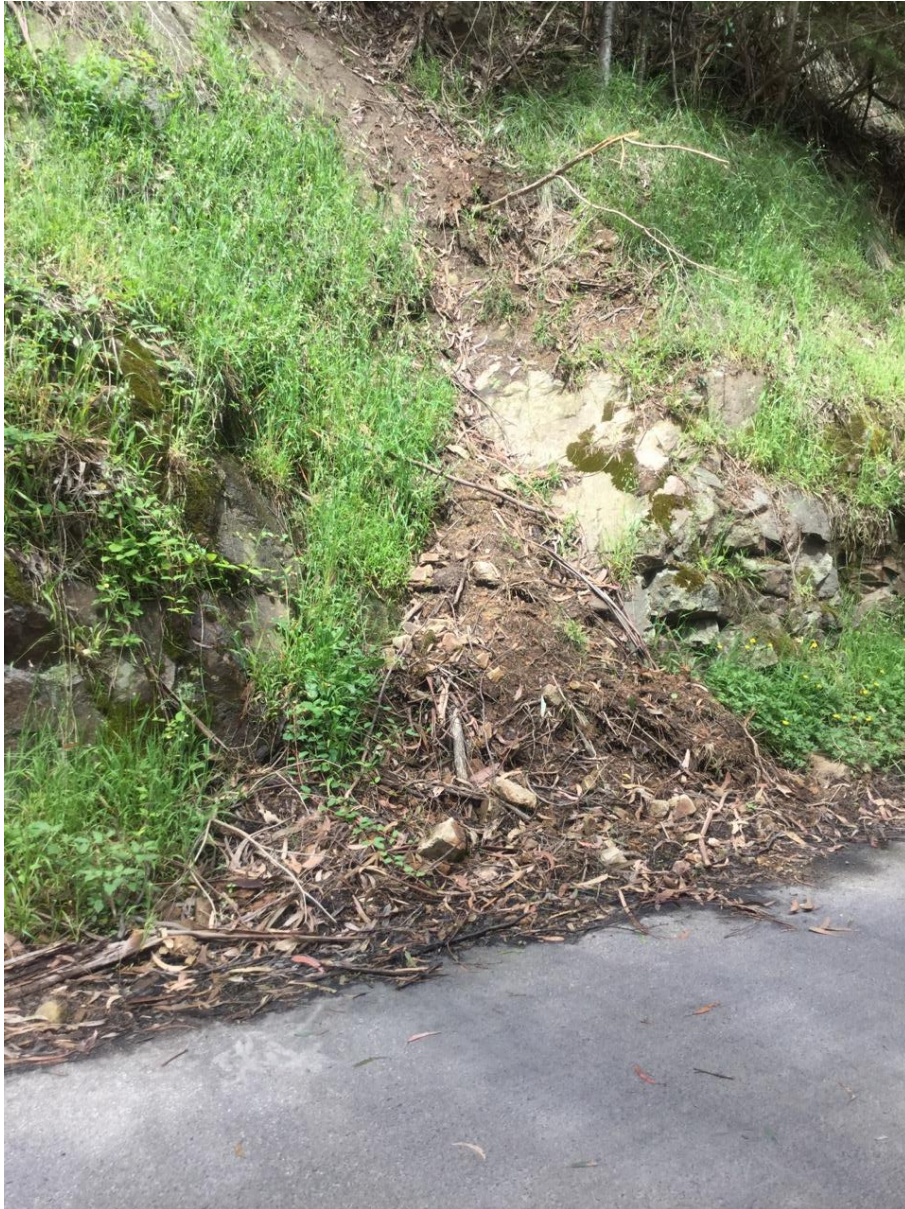
Photo 11 Recent debris material transported from above soil slopes down rock chute

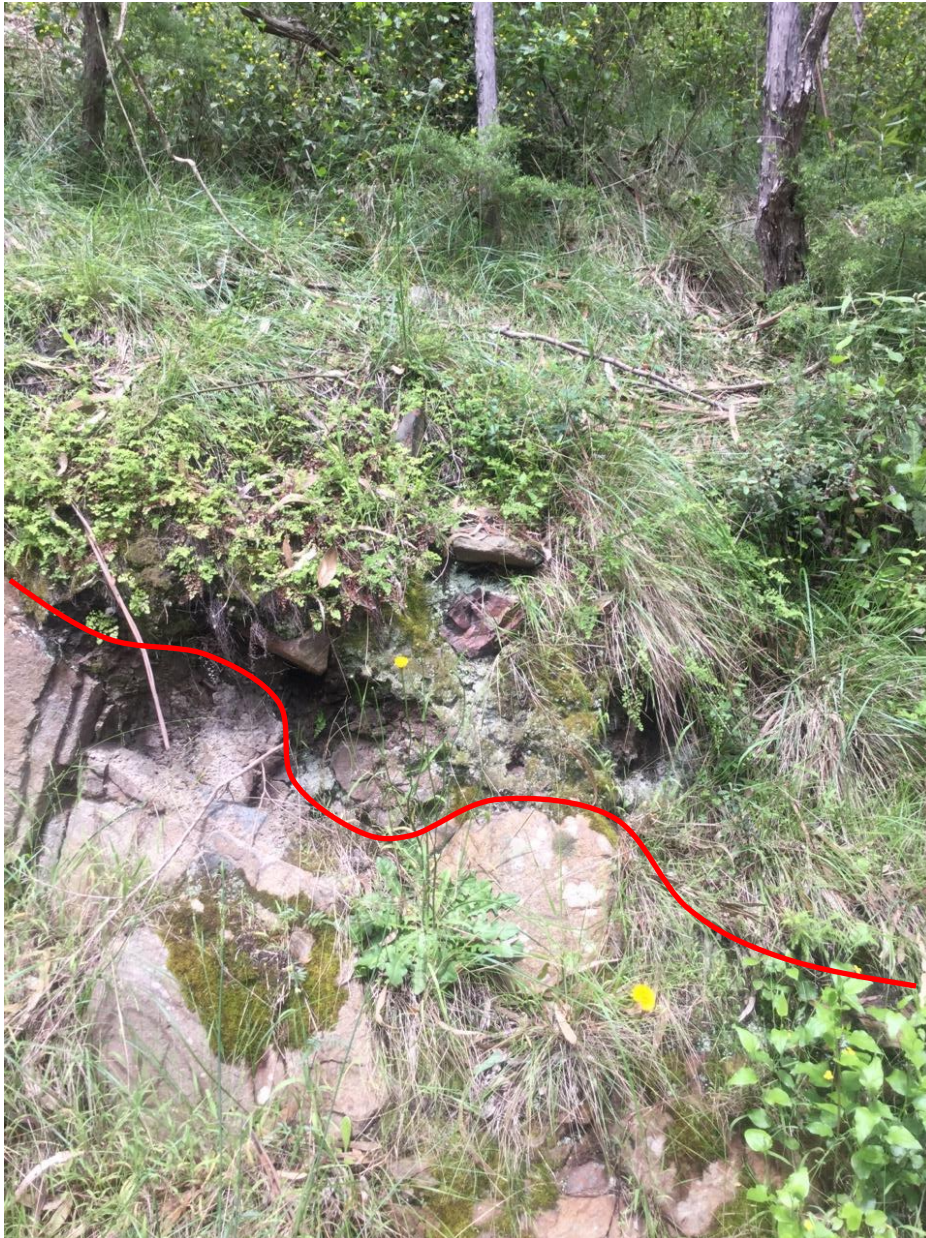
Photo 12 Thin cover of colluvium overlying dyke rock outcrop

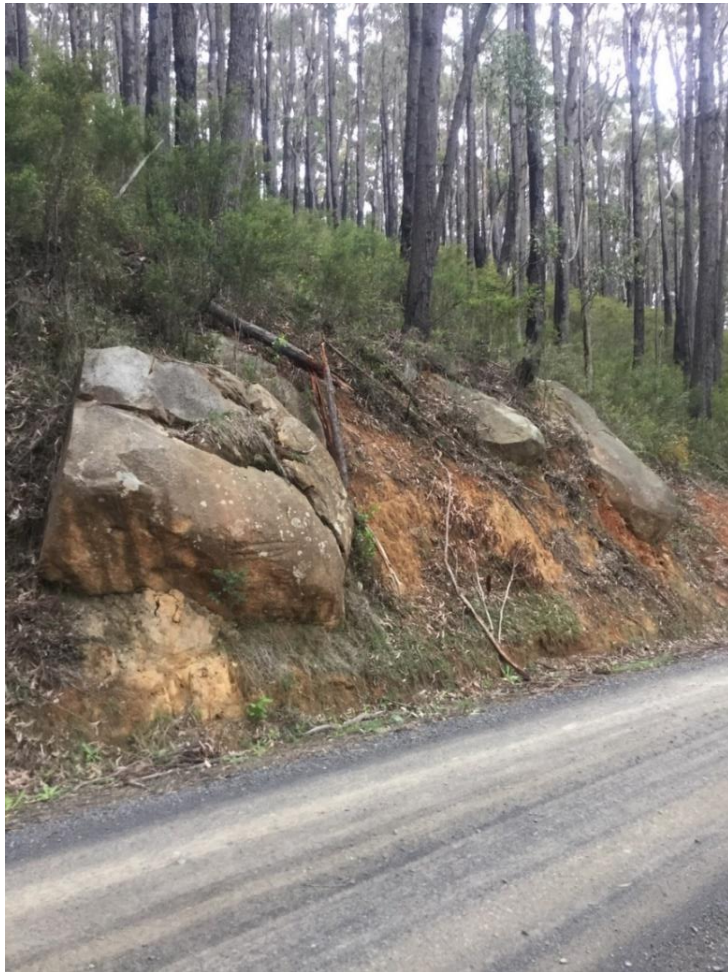
Photo 13 Granodiorite soil profile with large (up to 4 m) corestones in a soil matrix

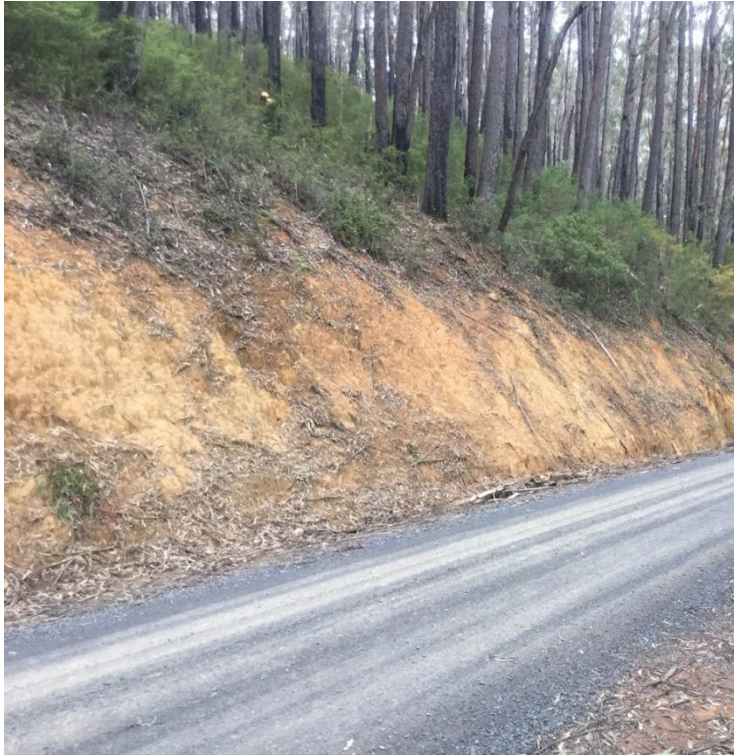
Covering a large section of the site south of Warburton, the Warburton Granodiorite forms hillsides with smooth slopes of varying grades. Road cuttings up to 4-5 m in height were observed to be stable with a slope angle of 50-60° from horizontal.

Photo 14 Road cutting in granitic soil standing at approximately 50-60 degrees

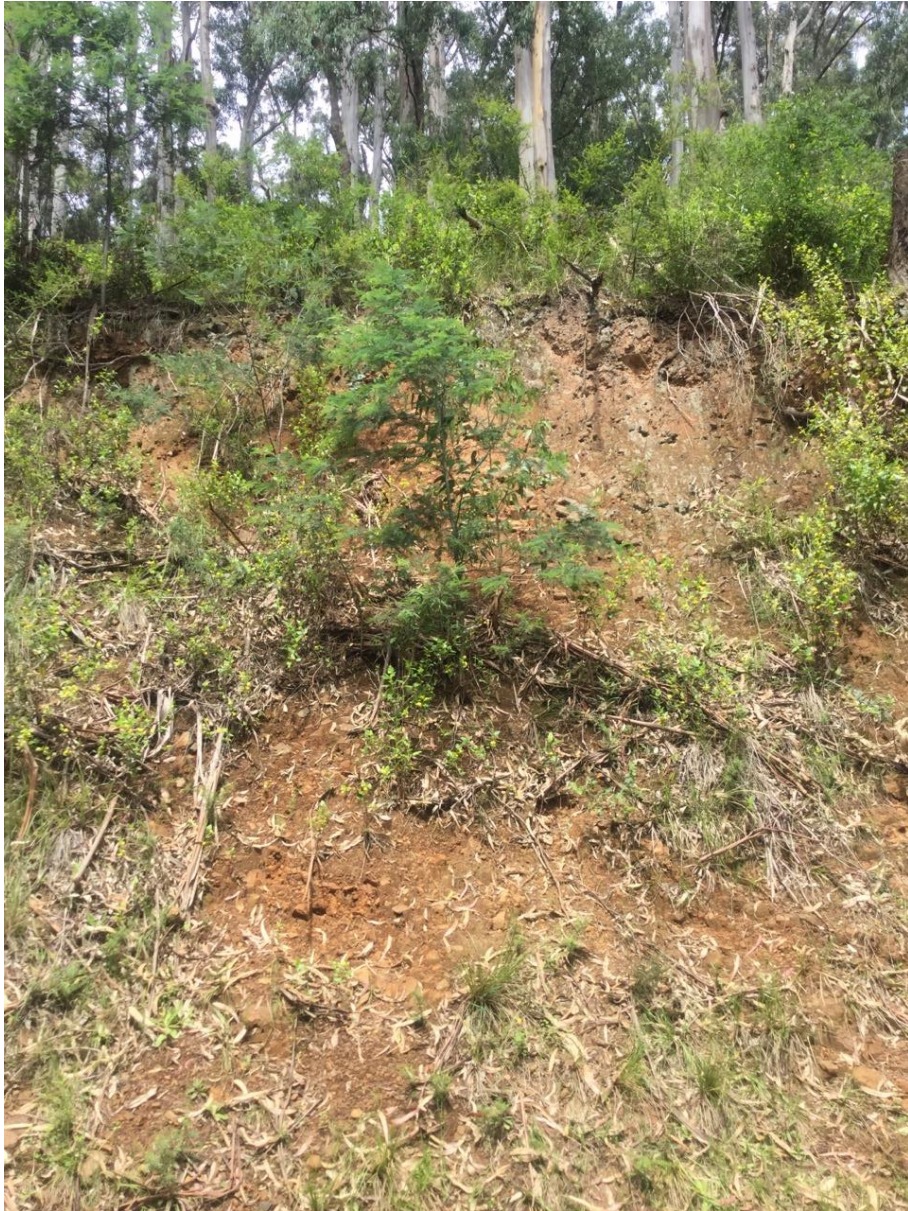
Photo 15 Steep road cutting in residual to extremely weathered siltstone

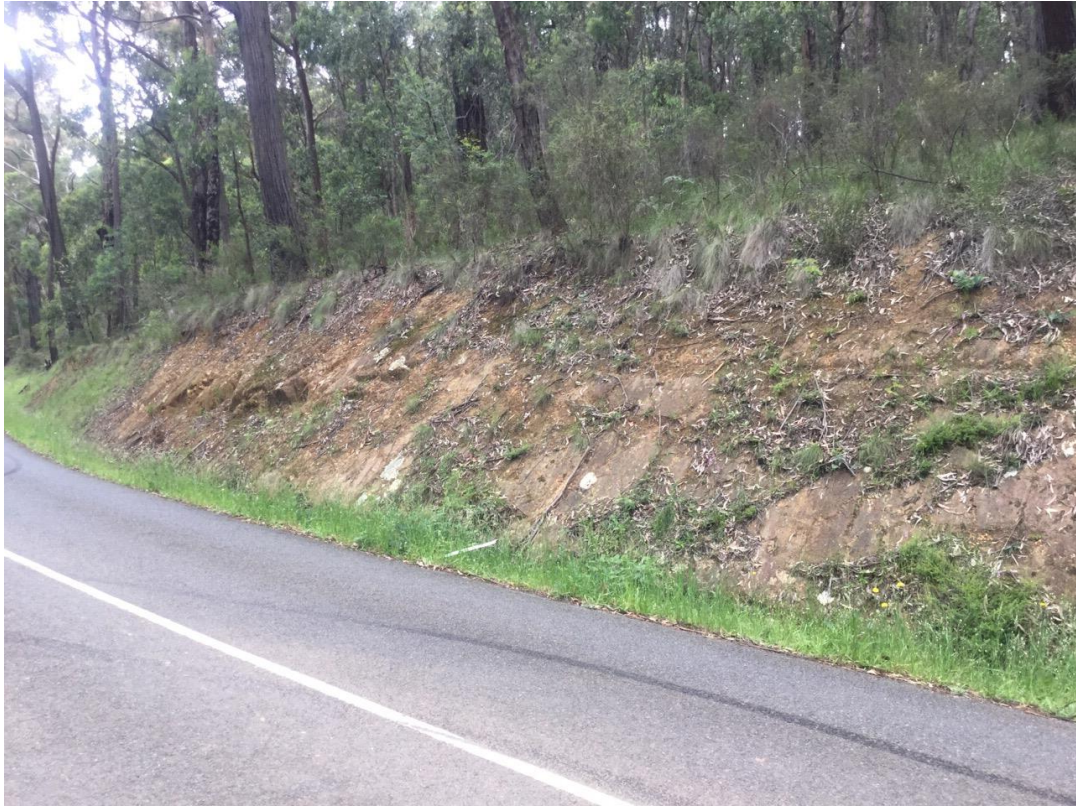
Photo 16 Road cutting showing thin soil cover (1-2 m) overlying siltstone rock
