Yarra Ranges Shire Council
Warburton Mountain Bike Destination Project
Geotechnical Risk Assessment

December 2019

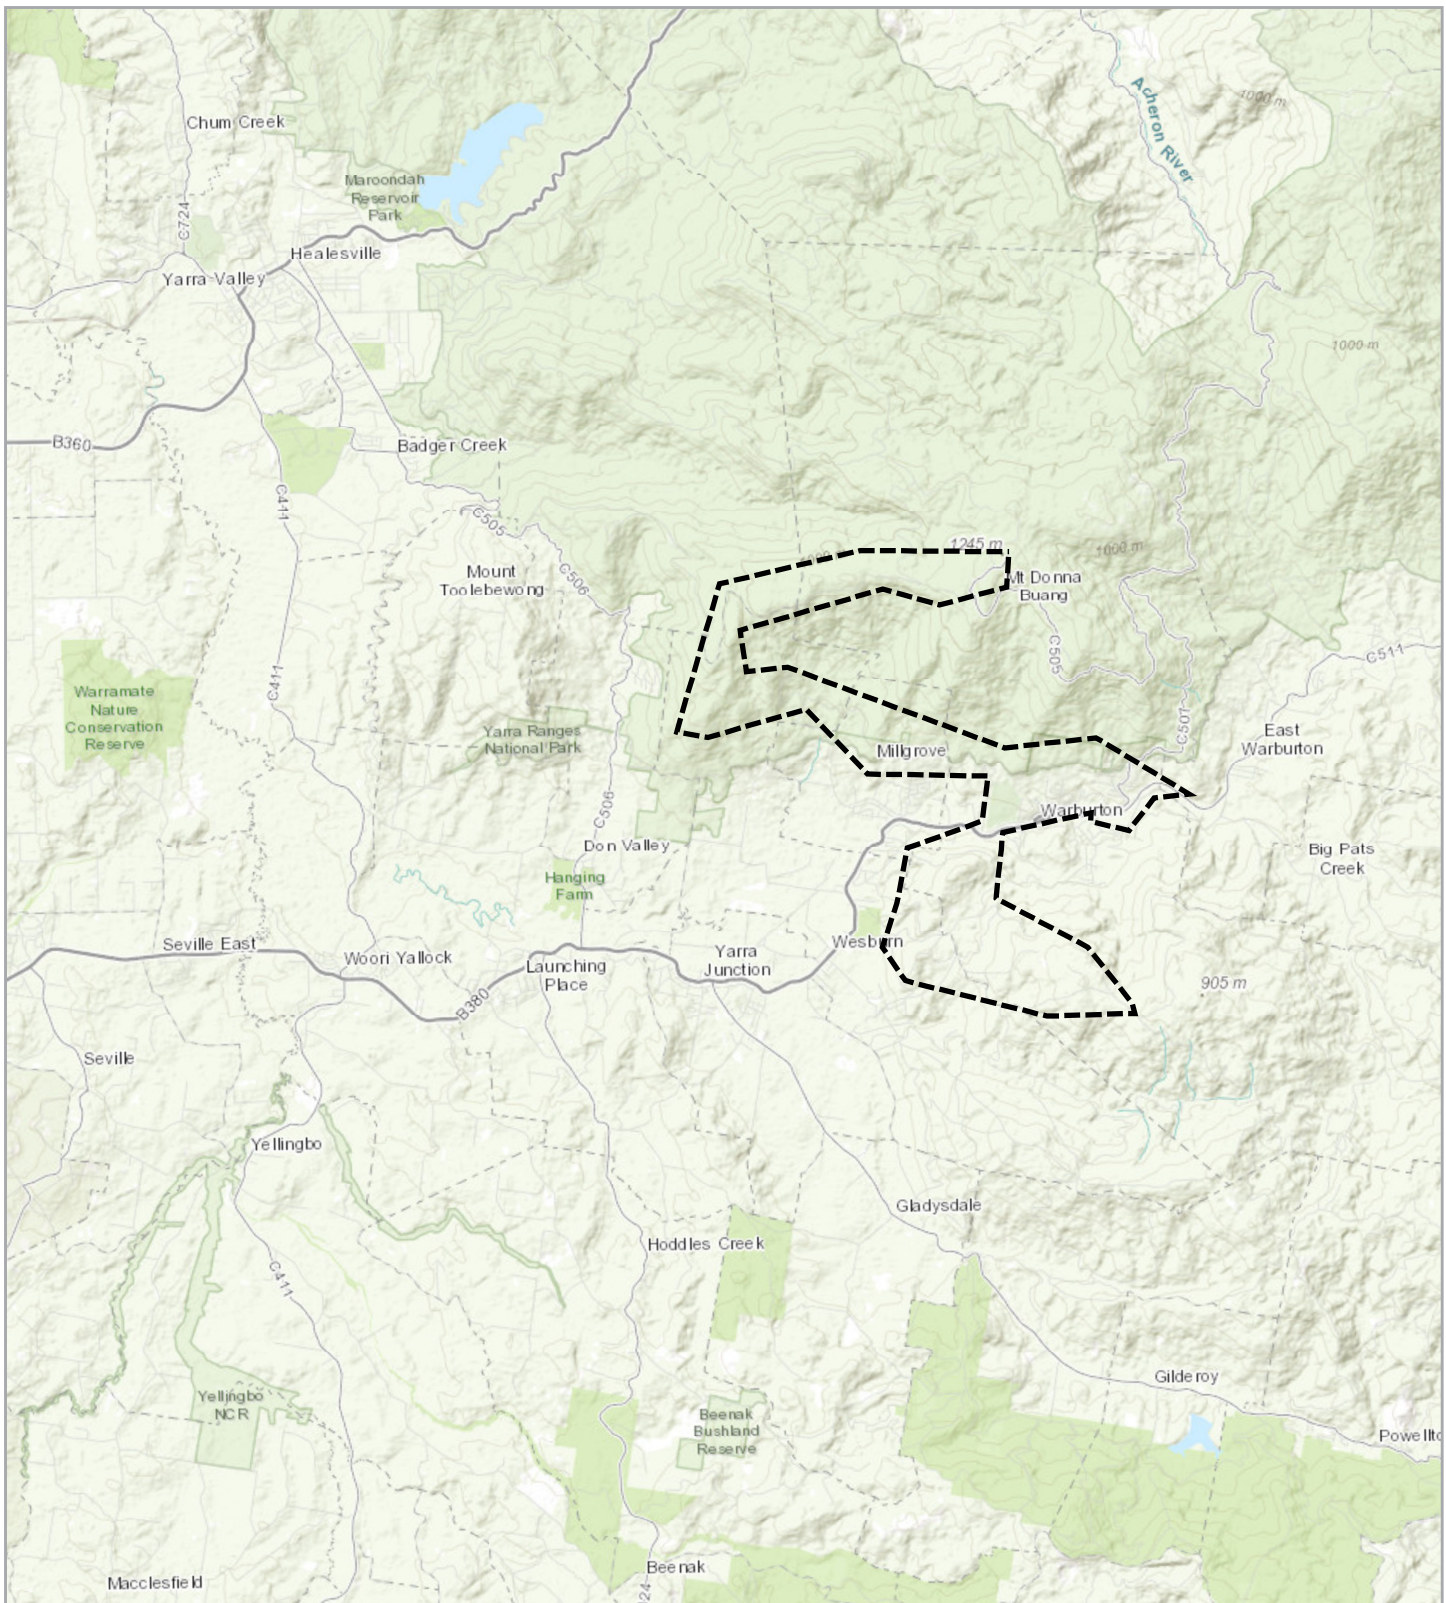
Figure 1

The Warburton Mountain Bike Destination Project (the Project), is situated near Warburton in the Yarra Ranges, Approximately 70 km north east of Melbourne (Figure 1). The project will involve the construction of world-class mountain bike trails, new accommodation and a visitors hub, to stimulate economic growth in the region through tourism and recreation.

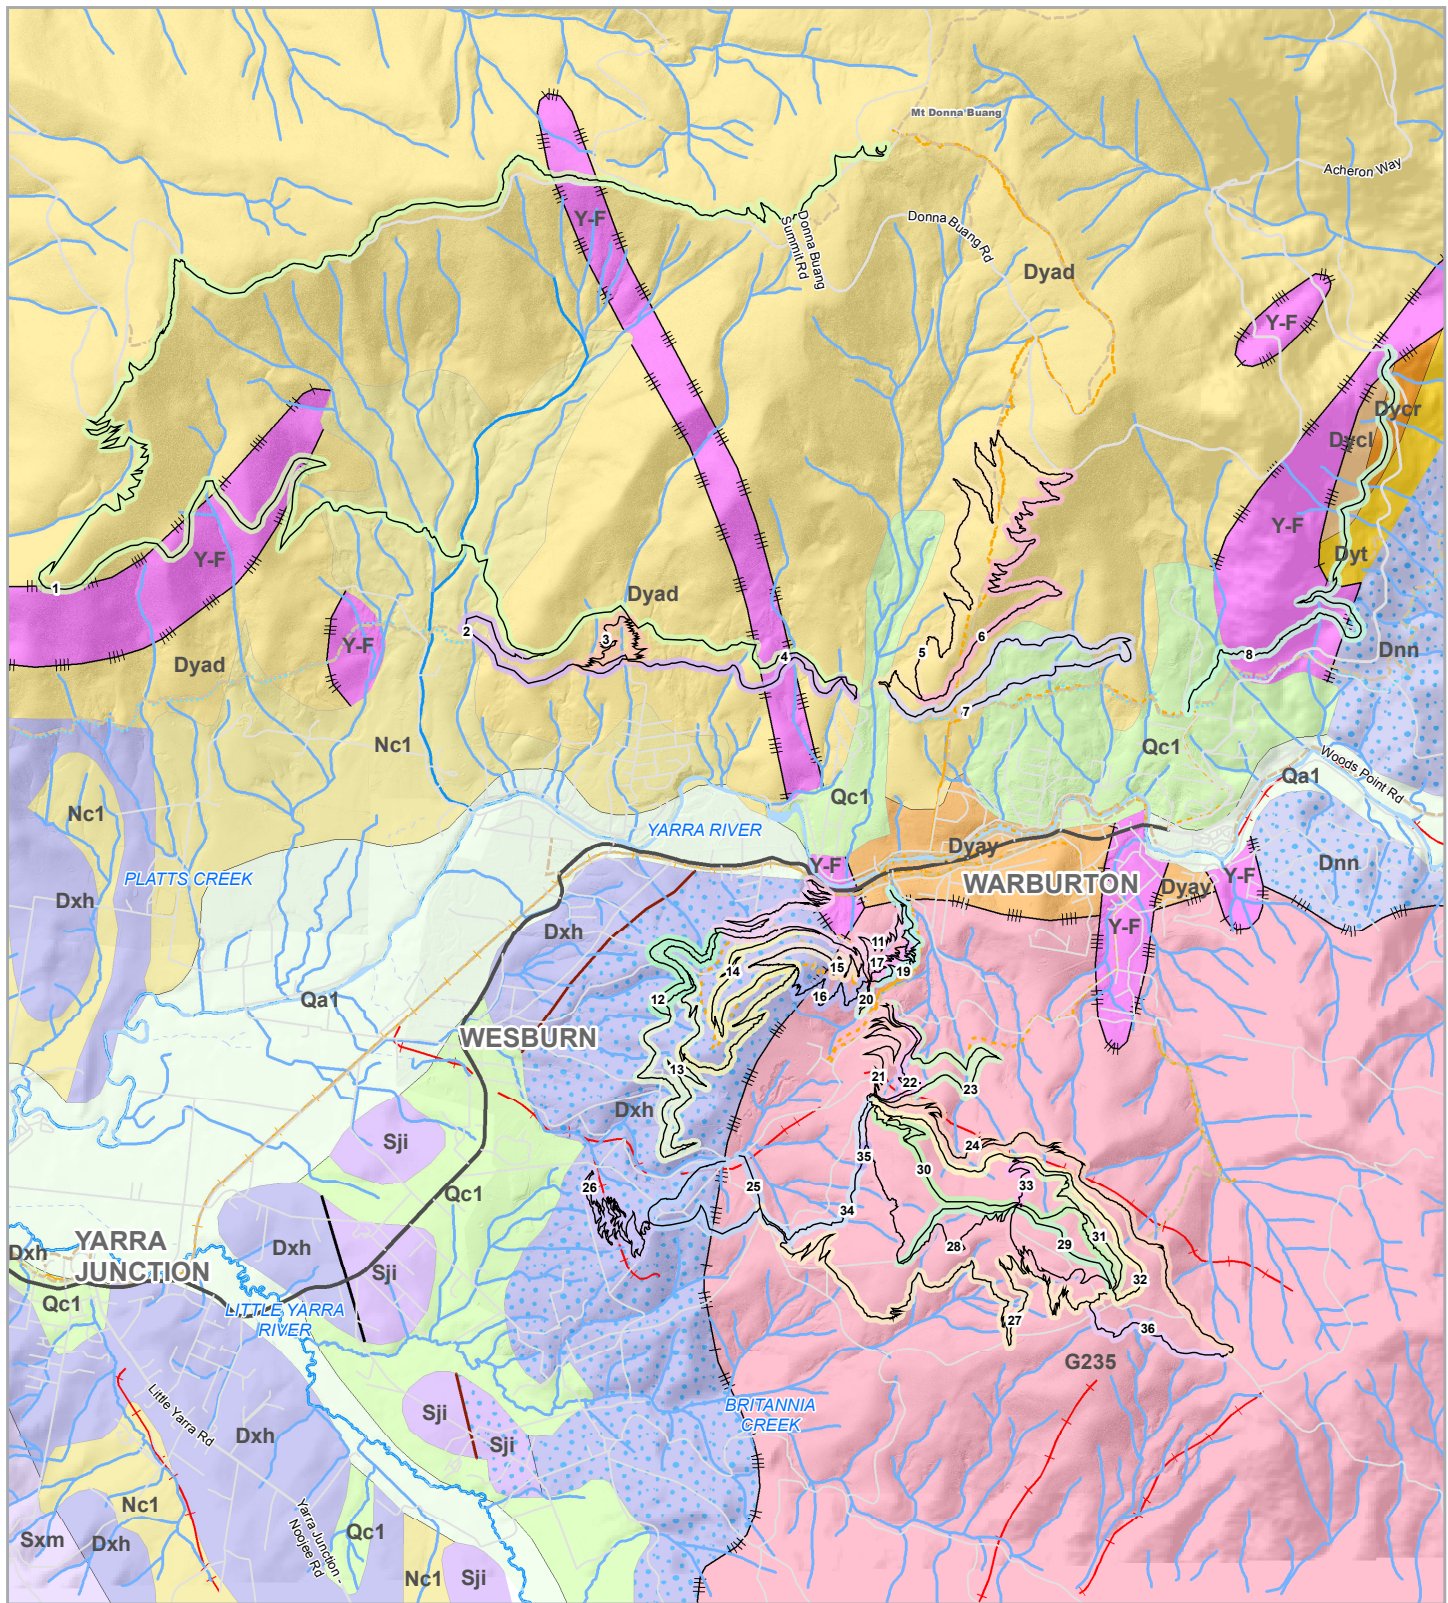
The 1:250,000 Geological Survey of Victoria map of Warburton (1997) and Coffey Report (ref: M2964/1-CF) suggest the geology of the site is made up of several major units that can be roughly divided between north and south of Warburton town, highlighted on Figure 2.

Geological unit	Geological age	Description	Figure 2 reference
Donna Buang Rhyodacite	Late Devonian	A thick extrusive volcanic deposit which has formed a mountainous area	Dyad
Humevale Siltstone	Silurian to Early Devonian	Siltstone that has undergone contact metamorphism to produce hornfels as a result of baking from the Warburton Granodiorite	Dxh
Warburton Granodiorite	Late Devonian	An igneous intrusion	G235
Felsic Dykes	Silurian to Carboniferous	A series of intrusive felsic dykes with similar composition	Y-F
Ythan Creek Rhyodacite	Late Devonian	Extrusive volcanic deposit	Dyay
Colluvium	Quaternary	Deposits include poorly sorted gravel, sand, silt and clay with zones of cobbles and boulders	Qc1
